# Case study: restoring form and function with implants and veneers

**Nilesh Parmar** tackles a patient's neglected dentition to restore their smile without resorting to the 'Hollywood' look

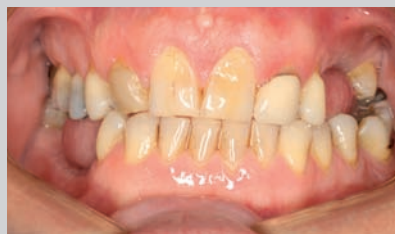
Figure 1: The patient at presentation
