Predictable anterior cosmetics

DR NILESH R PARMAR
presents an anterior implant case study, demonstrating predictable, aesthetic outcomes...

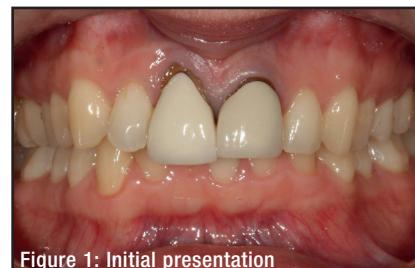
This lovely lady has had a history of treatment carried out on both of her upper central incisors since she was a child. A previous swing accident has resulted in large fillings, leading to crowns, then root canal treatment and, ultimately, the loss of the UR1. When I first saw the patient, the UR1 had a draining sinus, and required removal (figure 1).

Figure 1: Initial presentation

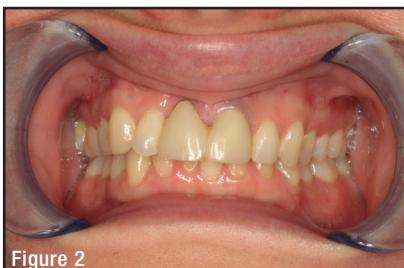
Figure 2

The UL1 was used to fabricate a temporary bridge to help start developing the soft tissue profiles. Due to the recession around the UR1, not much soft tissue development could occur until the site was grafted at the time of the implant placement (figures 2-4).

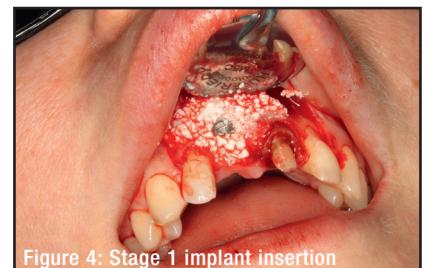
An Astra Tech TX Osseospeed implant size 4.5mm x 11mm was placed in the UR1 site. The entire buccal envelope was grafted using a bovine graft material and covered with a collagen membrane. The periosteum was undermined, helping to increase flexibility of the flap, allowing for adequate primary closure (figure 5).

Figure 4: Stage 1 implant insertion

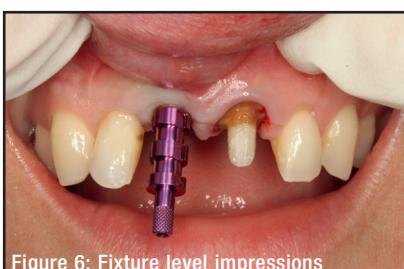
The patient healed without incident and the temporary bridge was reinserted with the pontic adjusted to help develop the soft tissue profile. The site was allowed to

heal for three months (figure 6).

Figure 6: Fixture level impressions

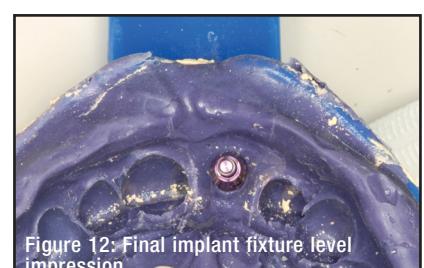
Figures 7-10 – The temporary crown on the UR1 was left in-situ for six weeks, with occasional adjustments made to the apical section. After six weeks, another fixture level impression was taken and an Atlantis Zirconia CAD/CAM abutment fabricated, with a final e.max crown

Figure 12: Final implant fixture level impression

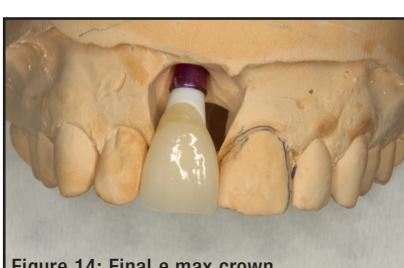
Figure 14: Final e.max crown

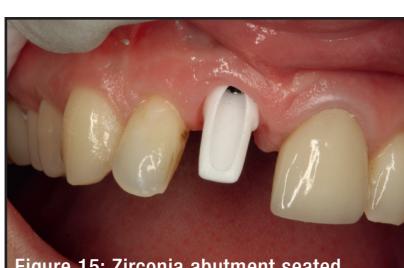
Figure 15: Zirconia abutment seated

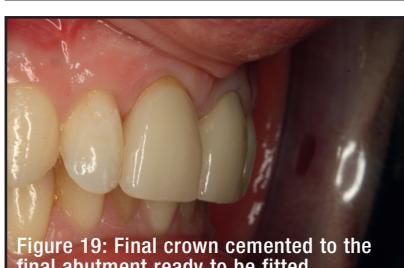
Figure 19: Final crown cemented to the final abutment ready to be fitted

cemented on top (figures 11-20).

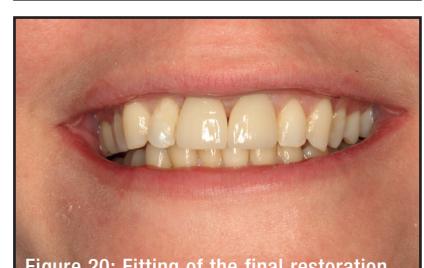
Figure 20: Fitting of the final restoration
