# DIGITAL DENTISTRY

## CBCT in implant dentistry

**Dr Nilesh Parmar** presents a case study using CBCT to aid in implant dentistry

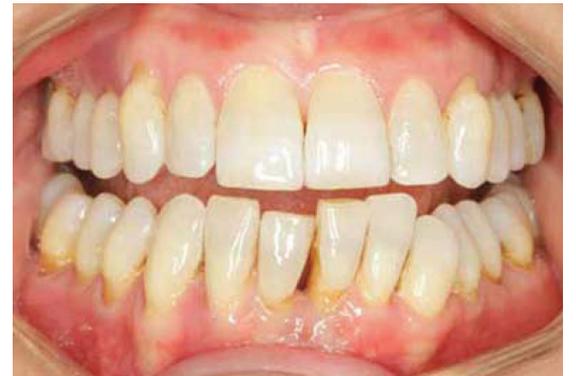
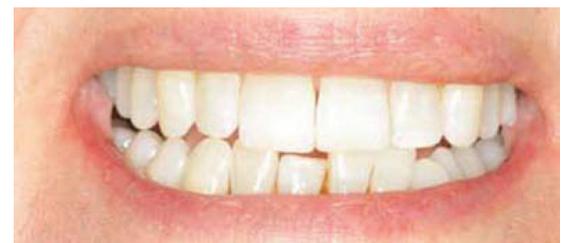
**Figures 1 & 2** Pre-op presentation

It was decided to take a full-volume CBCT scan to further assess the upper teeth and tooth UR4 for future implant replacement. The CBCT scan showed excessive bone loss around the anterior incisors with a small area of periapical radiolucency around tooth LL1. A cross-sectional view showed thick, well-developed cortical plates with very

little lingual concavity. Owing to the good bone height and minimal pathology, immediate implant placement was planned.

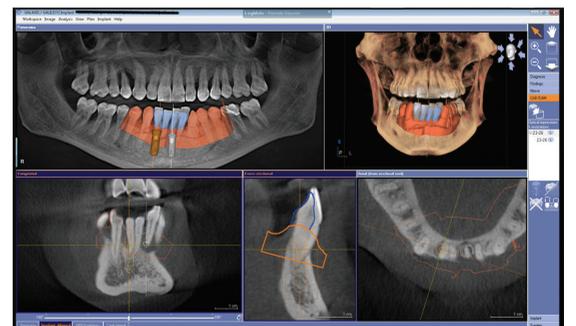
**Figure 4** CBCT scan with a Cerec Bluecam overlay showing ideal final result

To aid implant placement in the correct angulation a Cerec Bluecam image was taken and manipulated so that the lower tooth positions were in harmony with the rest of the dentition. This proposal was then overlaid onto the CBCT scan and was used to facilitate implant planning. The aim was to provide the patient with a screw-retained bridge with access holes through the lingual aspects of the lower incisors, whilst maintaining a sound margin of safety from the lingual cortical plate. Owing to the patient's previous periodontal history, it was decided to use Standard Plus implants (Straumann) in this case. The design of this implant incorporates a 1.8mm polished collar above the active surface of the implant. This results in the implant-to-abutment junction being located 1.8mm superiorly to the bone crest.

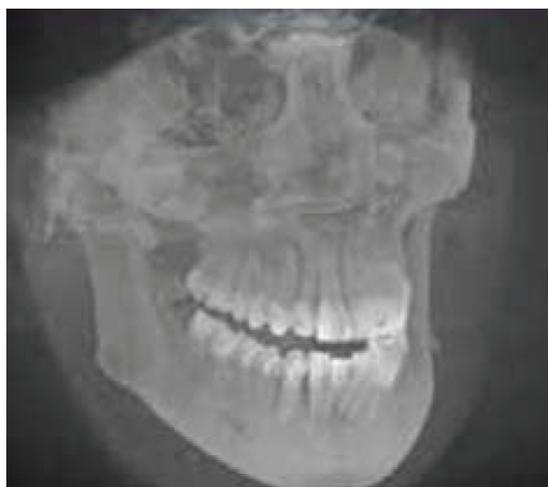
**Figure 3** Maximum intensity projection using Sirona Galileos

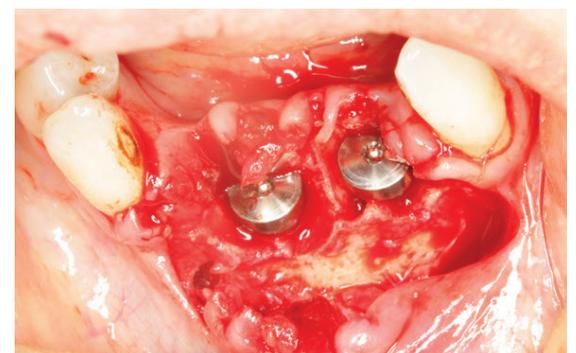
**Figure 5** Stage 1 of implant placement, with healing abutments in place

Implant placement was carried out using standard ITI (International Team for Implantology) protocols. Two Slactive Standard Plus implants (4.1 x 10mm, Straumann) were placed. The implants exhibited excellent primary stability with an insertion torque of greater than 35Ncm. The patient's bone quality was estimated to be type D1-2 (Lekholm & Zarb 1985). Owing to the high primary stability and good bone quality, it was decided to adopt a single-stage surgical protocol, thereby placing healing abutments over the implants. The site was closed using 5-0 polyglycolide sutures and a tooth-supported denture replacing the lower incisors was fitted. Careful examination of the denture was carried out to ensure there was no contact or transfer of occlusal load onto the implants from the denture. The patient was seen seven days after surgery for suture removal and review.

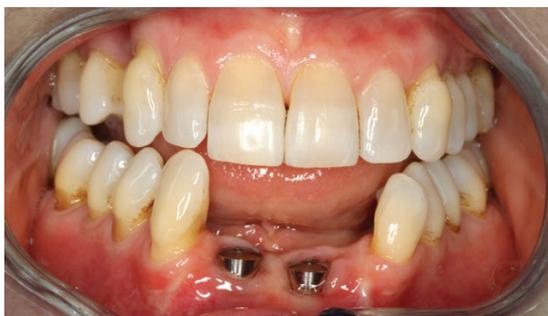
Figures 8 & 9 Laboratory-made screw-retained porcelain bridge on Straumann Synocta abutments

After eight weeks of healing, fixture-level open-tray impressions were taken in Impregum (3M ESPE) and a four-unit screw-retained bridge was fabricated. The tooth set for the denture was duplicated on the final bridge, as the patient was happy with the tooth size and shape. Owing to the previous bone loss, pink porcelain was added to the bridge to improve the emergence profile and reduce the crown lengths of the lower incisors.

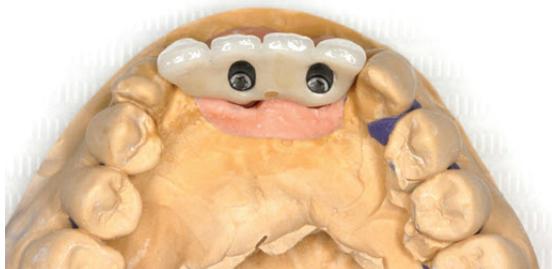
Figure 10 The bridge

The bridge was seated and torqued to 35Ncm and composite placed in the access holes. A baseline long-cone periapical radiograph was taken to serve as a baseline for bone-level measurements. The occlusion was checked, with the patient exhibiting canine guidance in excursive movements. The patient was shown how to clean under the bridge using super floss and Tepe brushes and placed on a long-term maintenance programme.
